## **NFK UNI Troubleshooting Guide**

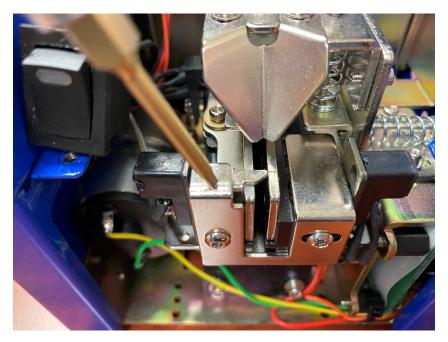
Rail:

Adjusting the rail: Sometimes during shipping or initial set up the rail can move from the original pre-set position. Often the rail is too far out towards the front of the presenter and simply needs to be pushed back a small amount in order for it to properly line up with the sensors.
